# HONGKONG MARIDA INDUSTRY CO., LIMITED

**Brief introduction for PVC Click Vinyl tile installation**

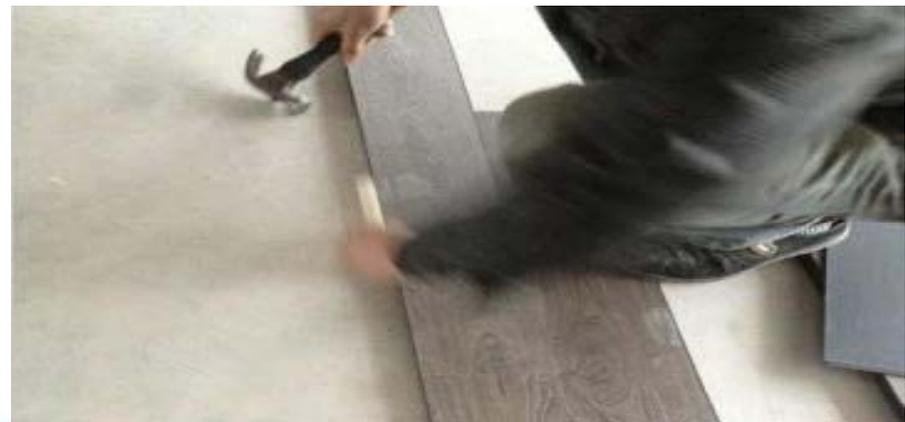
wrong method

7. Reading construction manual or contact with the local vendors (or producer) when you install the PVC click flooring. Installation should be finished by professional. It is easy to install after you understand the correct installation method. Using the Wood or iron hammer to beat the click type is not allowed, the click type will be broken and lead to Installation anomaly.

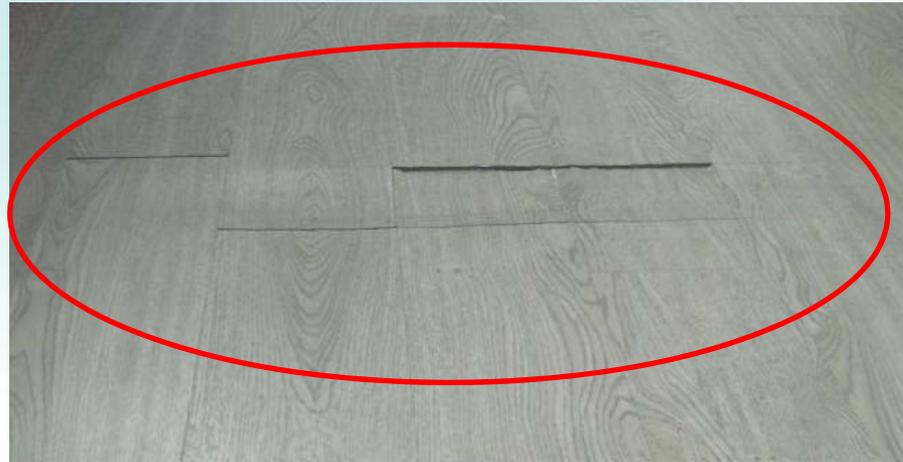
## Common defective phenomenon: floor is out of fairness

Defective phenomenon : the floors are seriously damaged and cracked, which affects function of use.  
The causing: the basement layer is not enough flat or without level detection or the treatment result doesn't meet the requirement.

Solution: Using leveling instrument to do level detection, Within two meters in diameter, the roughness is less than 2 mm, if it exceeds standards, some relevant treatment need to be done.

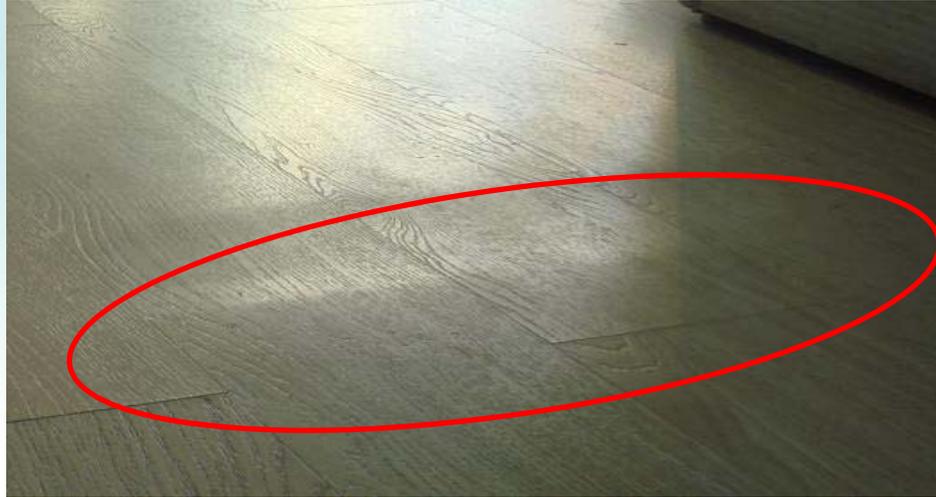
**Common defective phenomenon: floor is out of flatness**

Defective phenomenon: the floors are sunken and curling, affecting their using function and beauty slightly.

The cause: the basement layer is not flat enough or without level detection.

Solution: Using leveling instrument to do level detection, Within two meters in diameter, the roughness is less than 2 mm, if it exceeds standards, some relevant treatment need to be done.

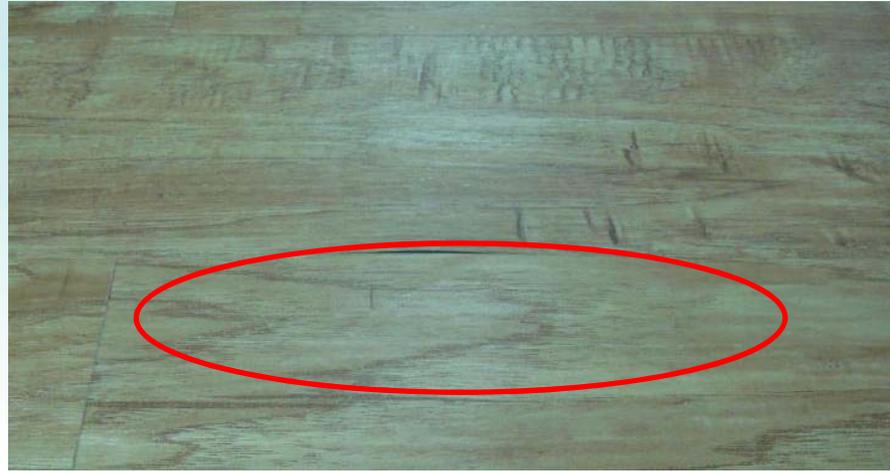
## Common defective phenomenon: the floor is impurity

Defective phenomenon: the long side of the floor is jack-up seriously and edge wrapped, the click type is damaged, which affects function of use.

The causing: the basement layer is impurity, without cleaning before installation or there is impure when installed.

Solution: surface cleaning must be done before installing, to reach no sticking substance, no pollutant and dry without dirty. Attention must be paid when installation.

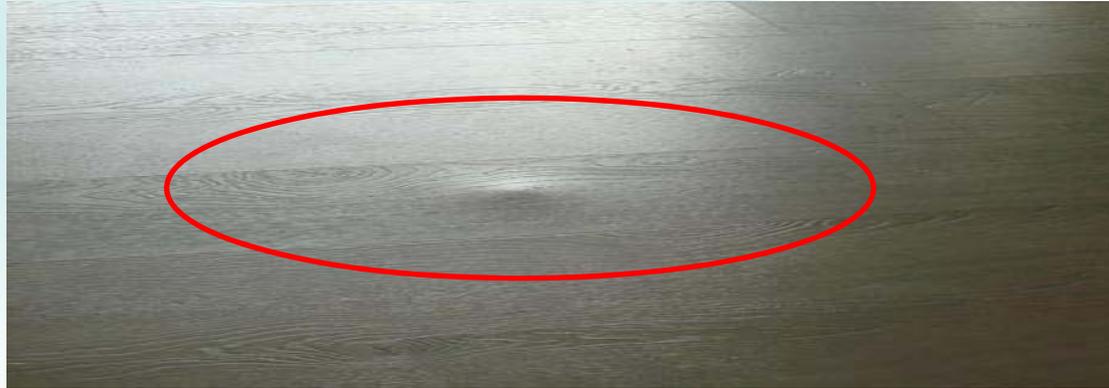
## Common defective phenomenon : Pollutants on the floor

Defect phenomenon, the floor topped seriously , affects the beauty .If this appears at the of buckle type position will cause warped edge and destruction of buckle type.

The causing: the based surface is sundry, no clearance before installation or pollutant when installing

Solution: No dung, no pollutants, keep dry, no dust should be ensured before installation and in the process of installation.

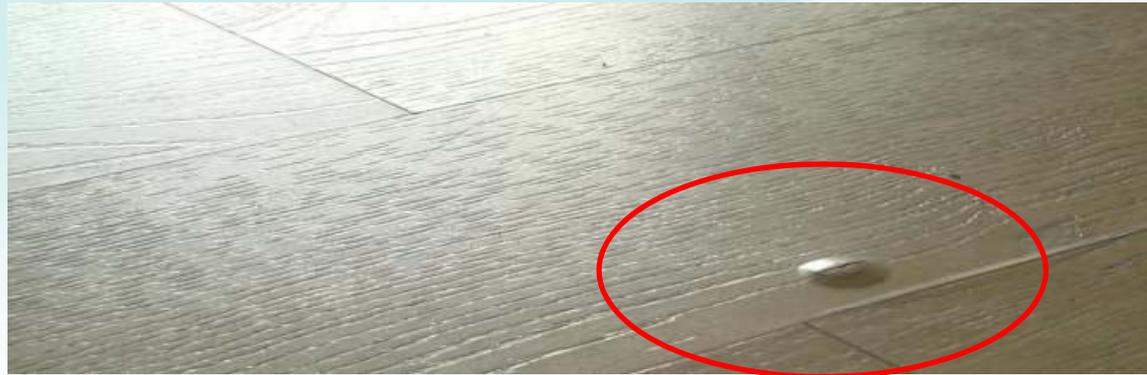
## Common defective phenomenon : Sharp objects on the floor

Defect phenomenon, the floor topped seriously and damaged , affects the function of use and the beauty .If this appears at the of buckle type position will cause warped edge and destruction of buckle type.

The Causing: sharp objet on the based surface , no clearance before installation or pollutant when installing

Solution: No dung, no pollutants, keep dry, no dust should be ensured before installation and in the process of installation

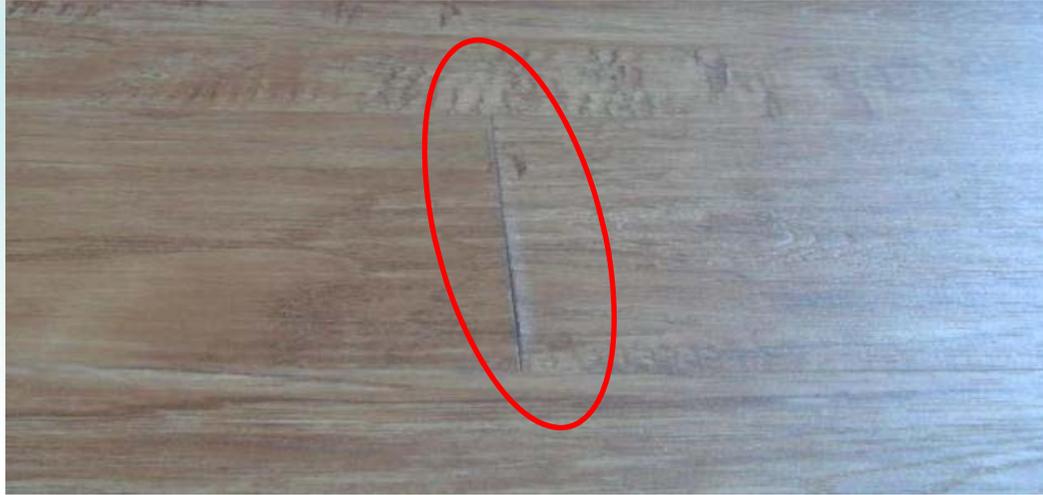
## Common defective phenomenon : click type damaged

Defect phenomenon : Tenon of the floor short edge become warped edge, affect the function of use and the beauty

The causing: floor damaged when being carried or the tenon damaged when installed with wrong method

Solution: pay attention to protect when carrying the floors and use the correct way to install

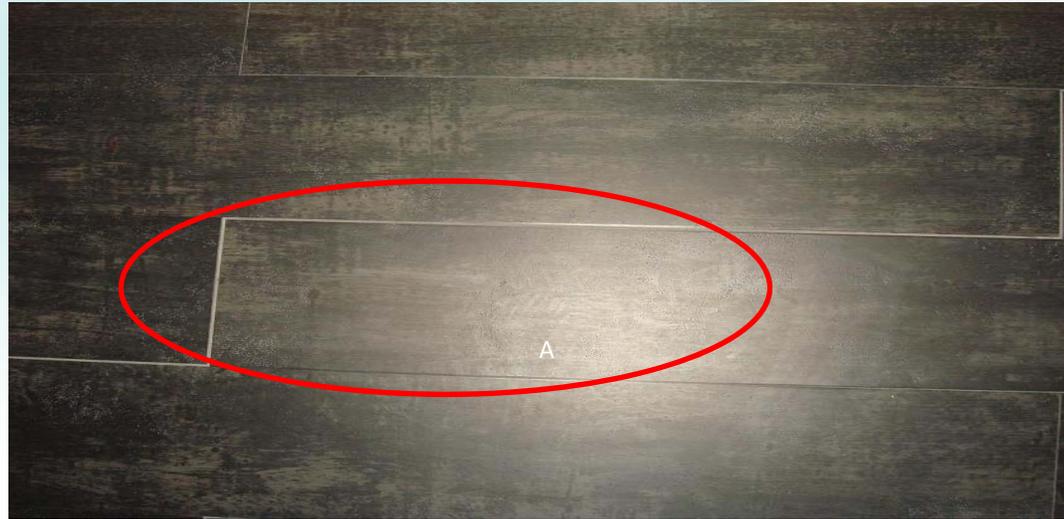
**Common defective phenomenon: Click drop out , can not install well.**

Defective phenomenon: both the short side and long side of the pvc plank drop click which affect the function and beauty of flooring.

The causing: the tenon of the short side of the plank breaks during moving or using wrong installation ways.

Solution: Protecting the PVC floors when moving and use the correct way to install floorings.

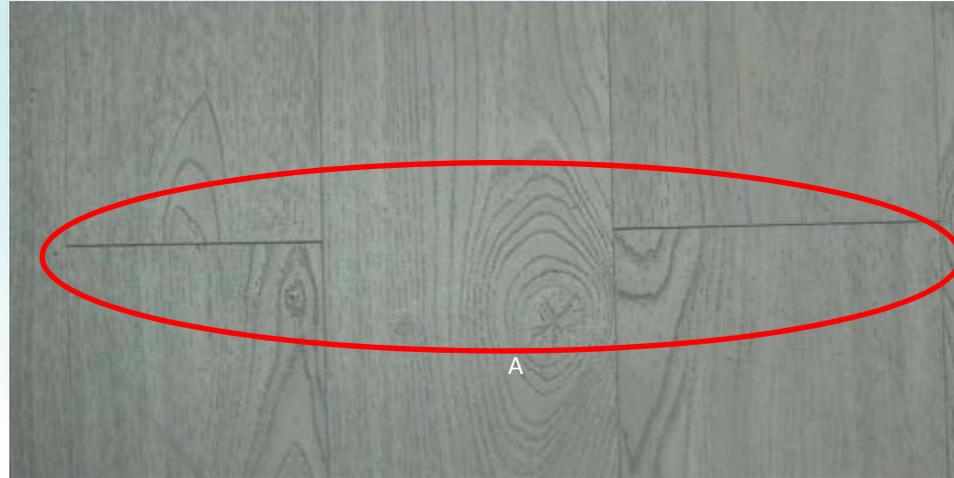
## Common defective phenomenon: big gap in the short side

Defective phenomenon: too big gaps will affect beauty of flooring.

The Cause ing: the temperature of the planks do not accordant to the environment or the temperature of installation exceeds as required.

Solution: Choose the correct installation temperature:20°C to 25°C , and put the planks into the installation room for at least 48 hours before installation.

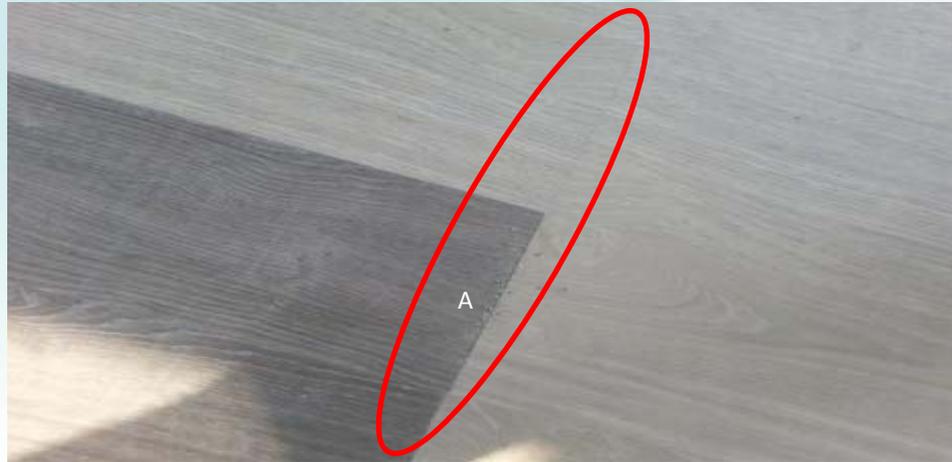
**Common defective phenomenon: Appear “one line shape”**

**Defective** phenomenon: short side of “One line shape” flooring will appear curling which affects the function and beauty of flooring.

The causing: using wrong installation (one line shape )way

Solution: choose the right way of installation: “a half” or “cutting planks into 3/6/9 pieces equally”
